## Conservation Project TT 110 (Tomb of Djehuty)

Khadija Adam – Conservator Manger ARCE Luxor

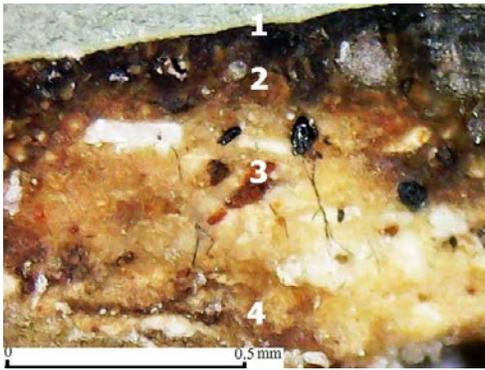
Layer 1	Fine dark color 75 $\mu\text{m}$
Layer 2	Thin layer from Hematite 85 $\mu\text{m}$
Layer 3	Gypsum and limestone fragments 400 $\mu\text{m}$
Layer 4	Sand + Gypsum

**Figure 9 - Cross section from Transverse Hall, East Wall, South section showing the layer sequences**
