Research Report

Al-Ahmadiyyah School in Aleppo

Restoration and Rehabilitation as

“Museum of Aleppo during the Ottoman Period”

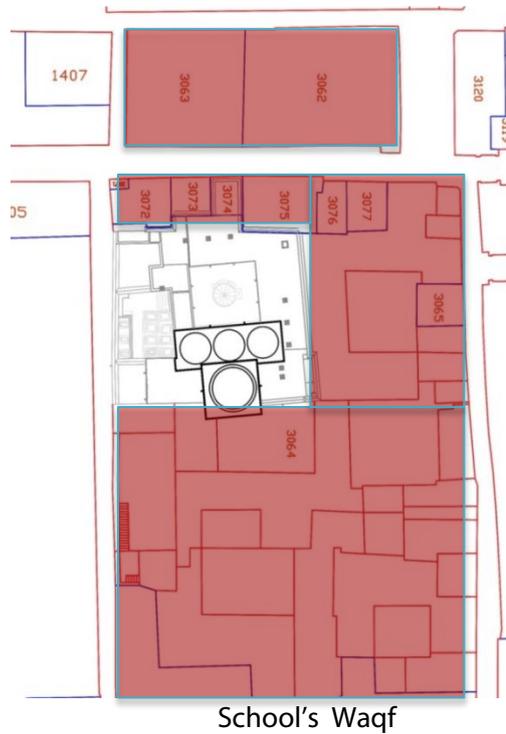
The locations of some of the endowments adjacent to Ahmadiyah School are shown in the following plan:

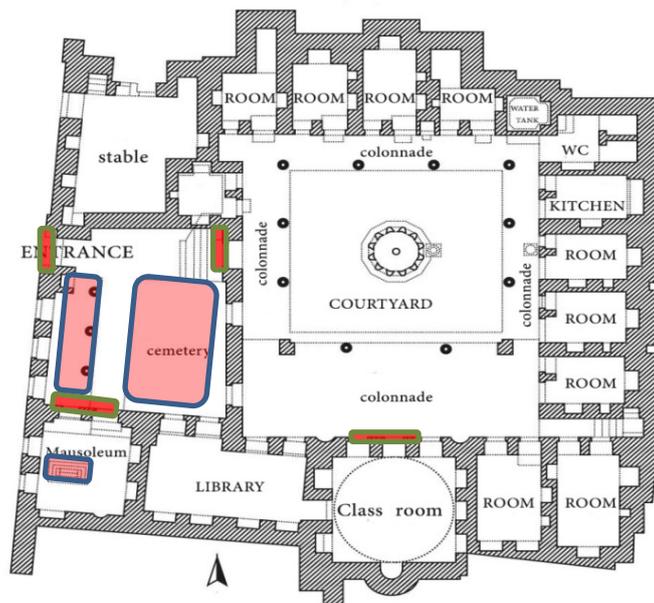
At this stage, analytical work was carried out on the plans of the school, including: Identifying the locations of the inscriptions and preparing drawings of them. Hence we see the distribution of these inscriptions on the main doors of the school in addition to the writings on the tombstones.

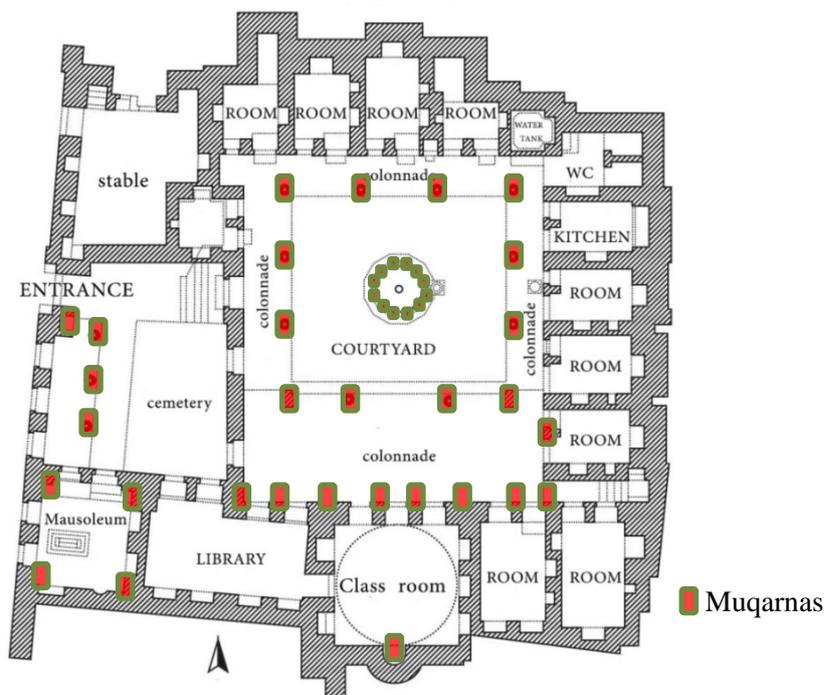
School's Muqarnas

Analytical plans have been also prepared for the locations of the Muqarnas. As we can see in the plan below, this school is considered to be very rich with Muqarnas:

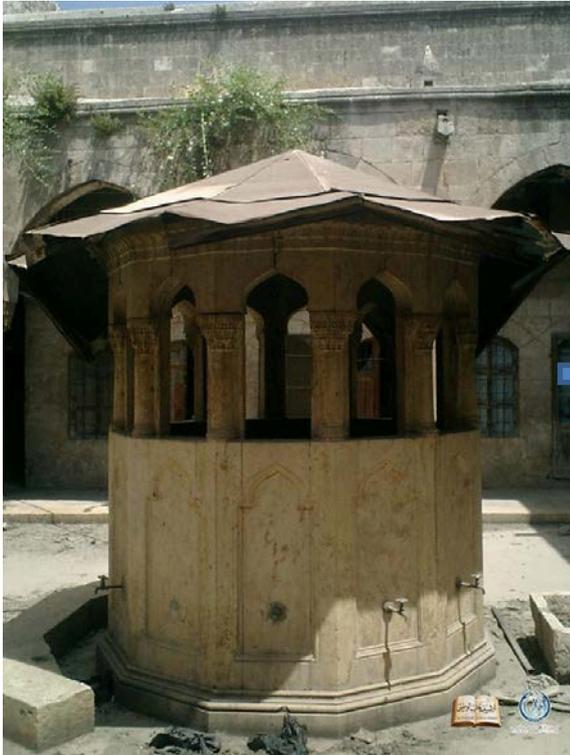
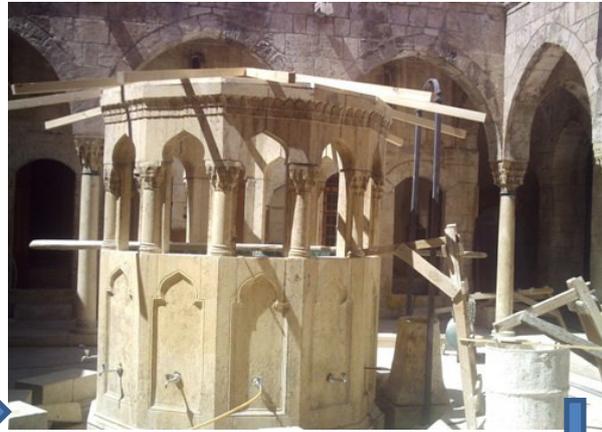
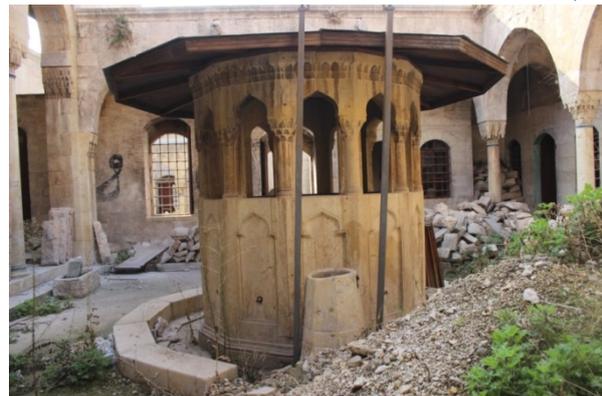
These pictures show the status of the water fountain before, during, and after the restoration:

In the previous figure, we see three pictures of the water fountain; the first picture dates back to 2008 before the restoration began, the second to 2009 during the restoration, and the third was taken 2014 during the war in Syria.

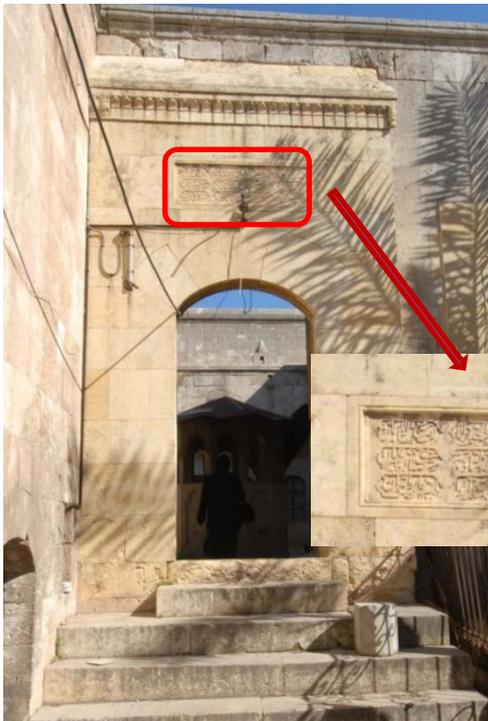
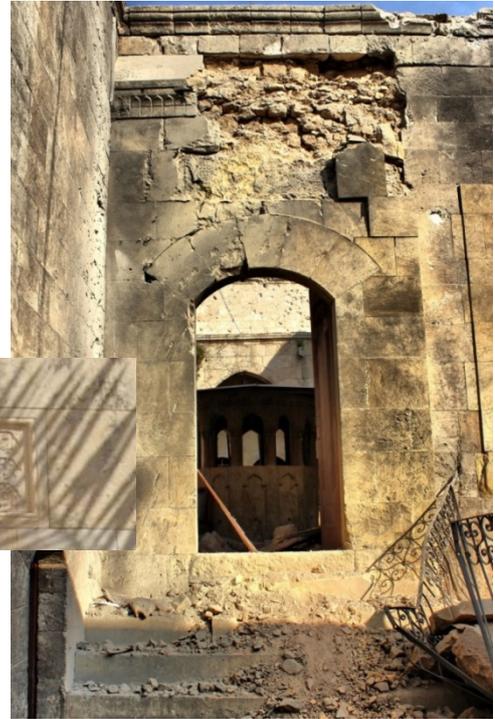
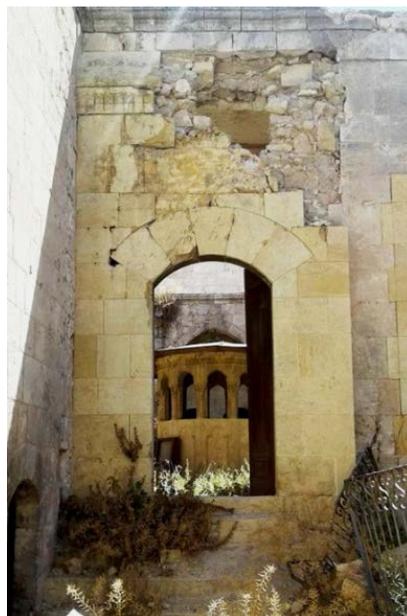
2017
The Entrance of the School

In the second phase, Data about the current status of school and pictures of the school were collected and compared to the previous situation and some analysing drawing was prepared to indicate the locations of damage. For example, the main door of the school was severely damaged in 2014, and during the period 2014-2016 a part of the wall was completely lost with the inscription above the entrance.

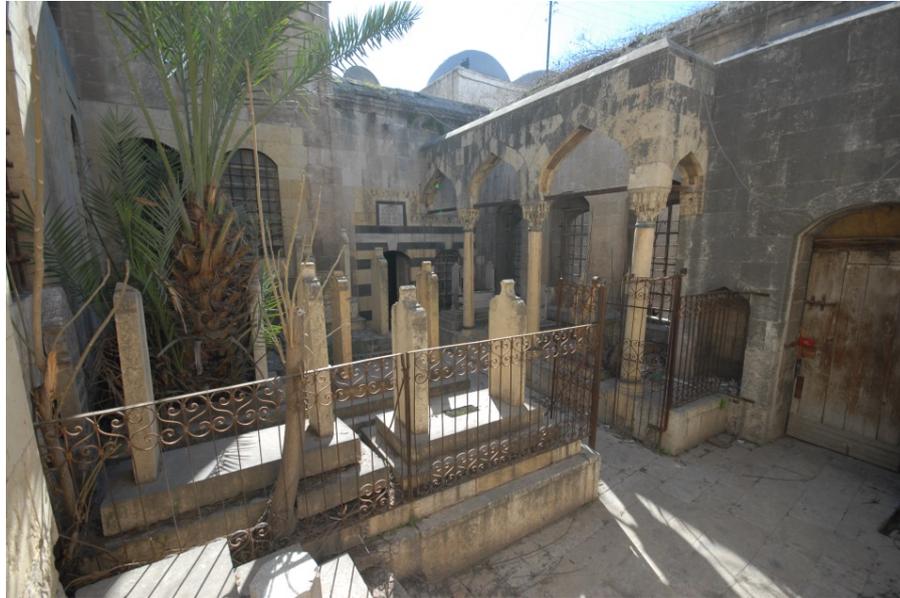
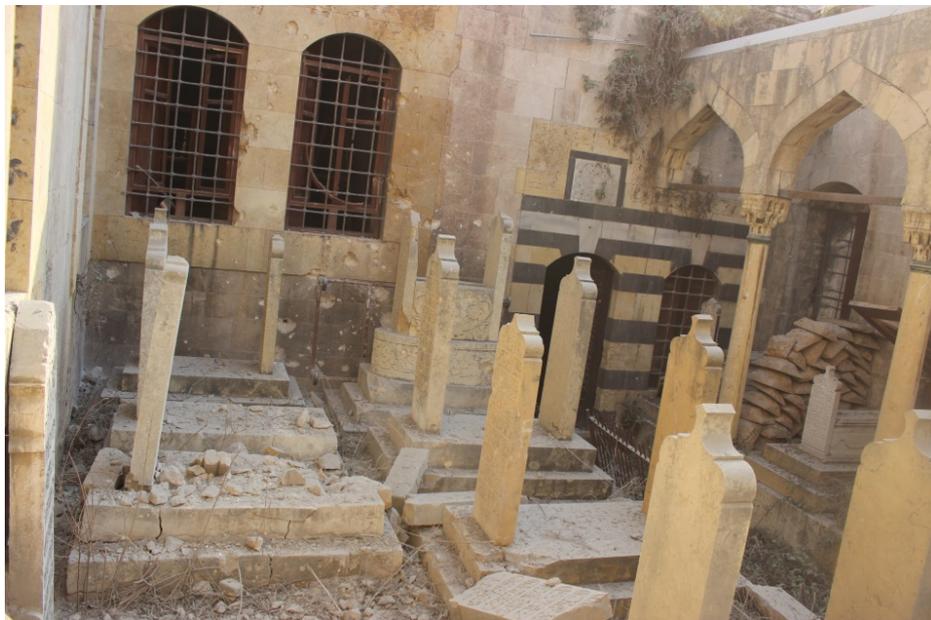
Another example, the graveyard also suffered great destruction, the following pictures also illustrate the destruction that took place in it, the first photograph was taken in 2008 and the second in 2014 showing the damage due to war.

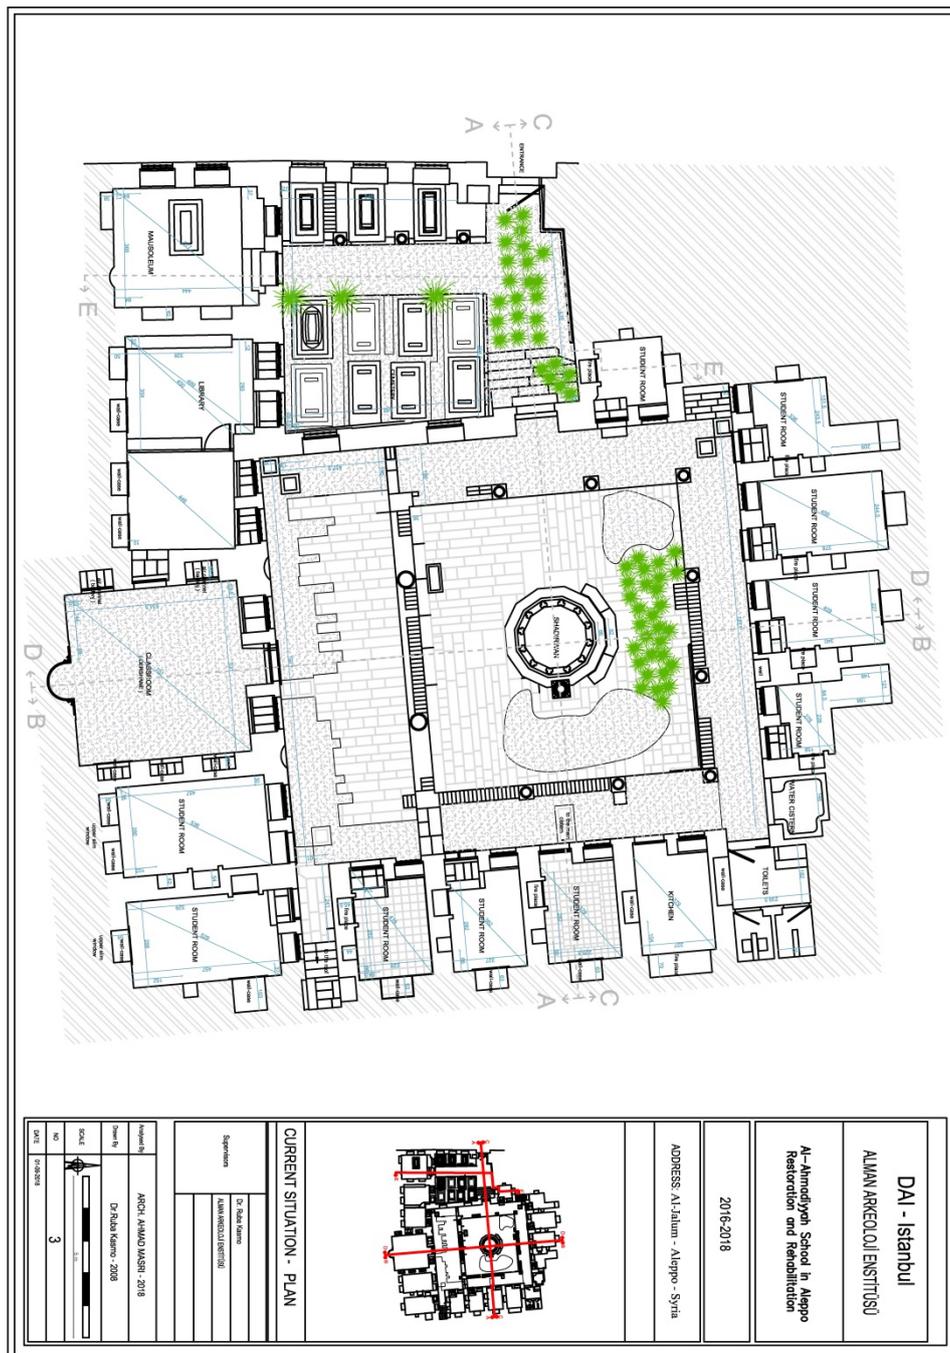
Current situation / plan of the school

Current situation plans: These drawings aim to show the current situation of the school by plans, sections, and facades.

For example, in the following figure, we find a plan showing the current situation of the school with names of spaces and dimensions.

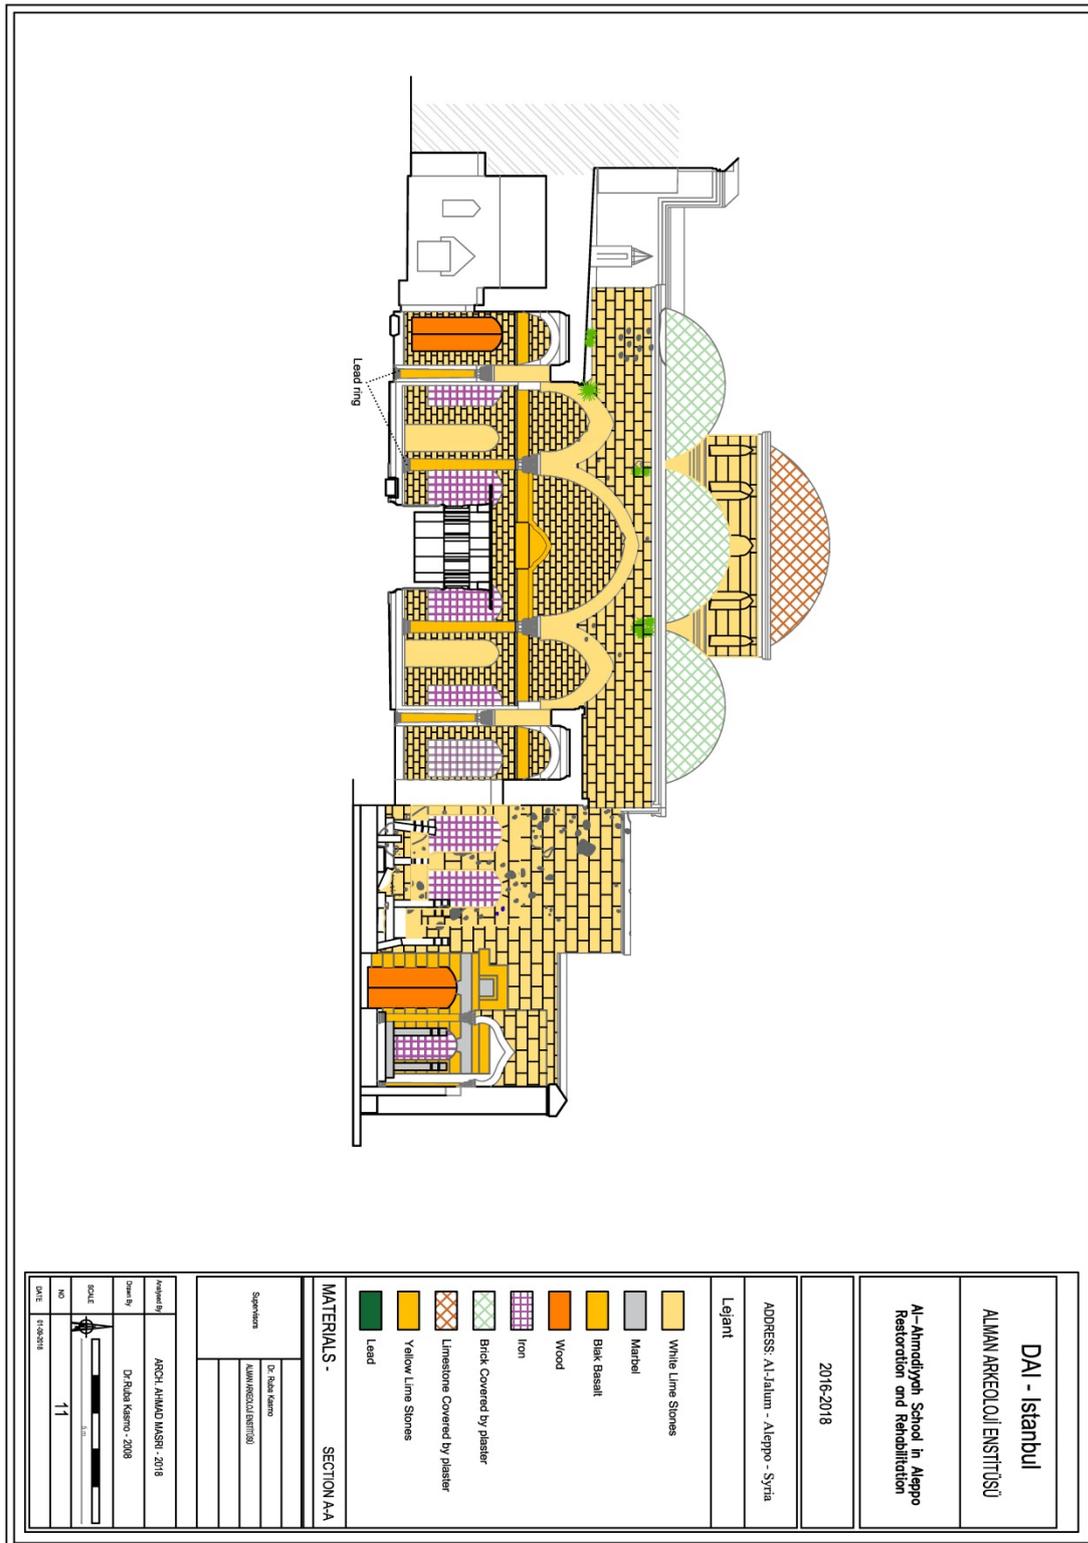
Materials / Section A-A

Materials drawings: These drawings aim to clarify the materials used to build the school, by means of color and hatches.

For example, in the following figure, we find a section showing the materials of the school.

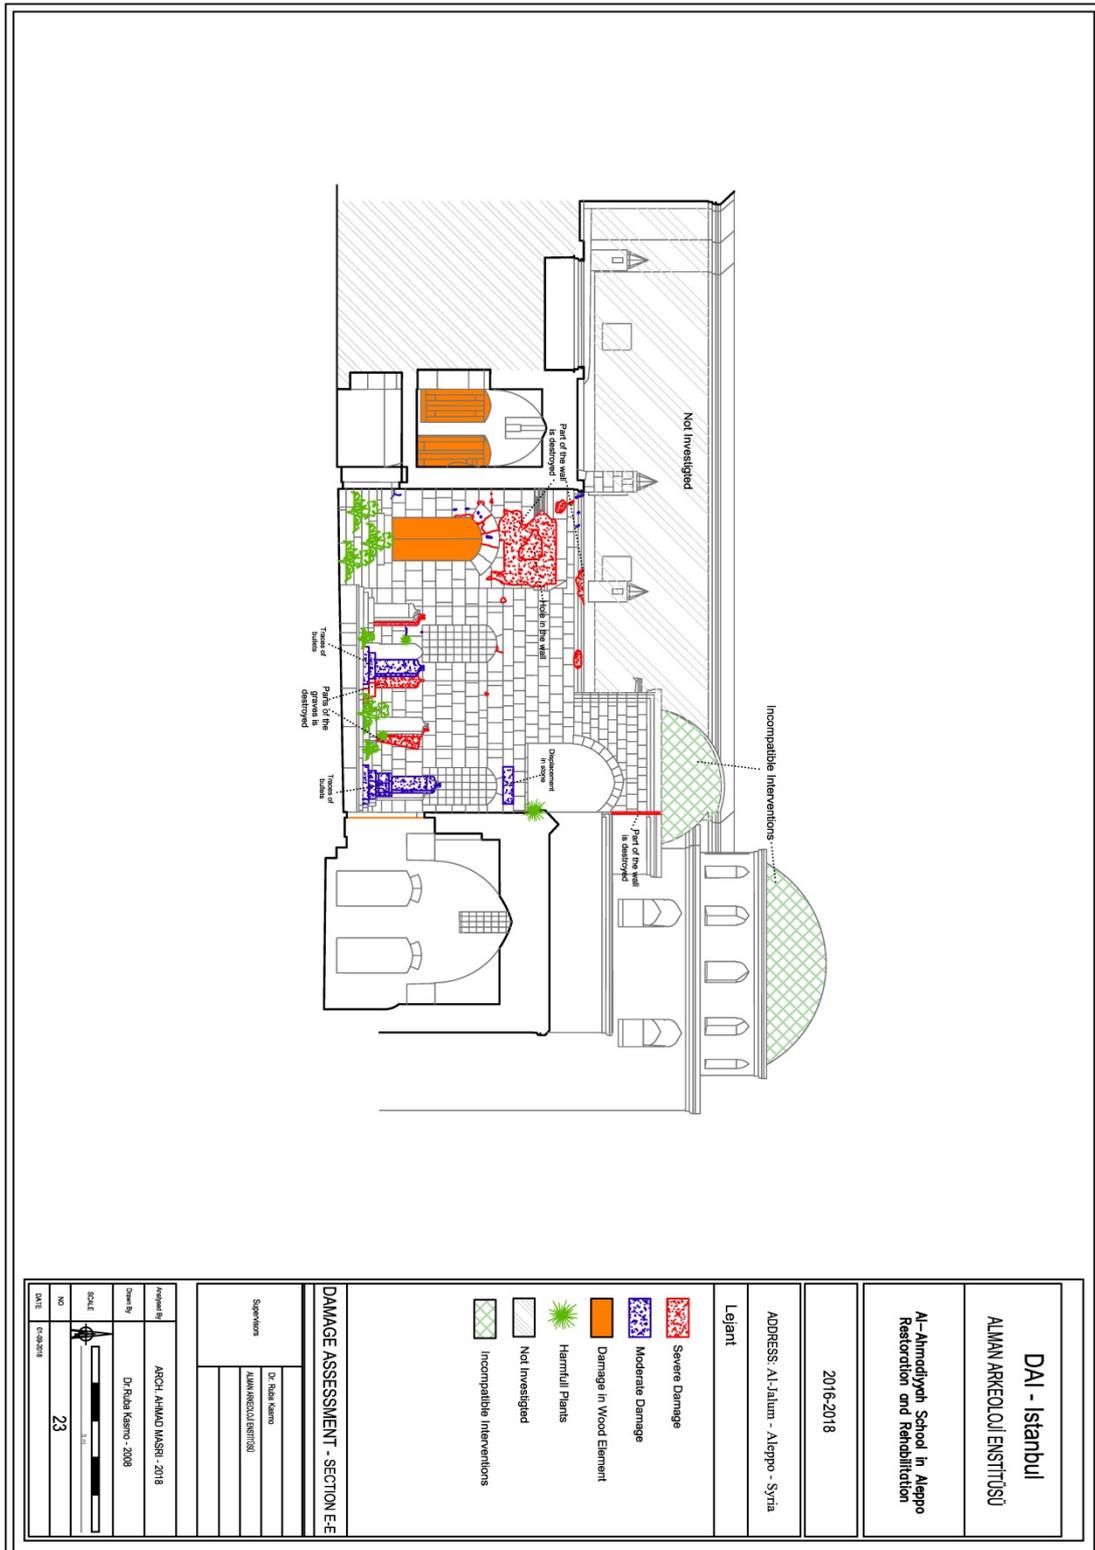
Damage assessment / Section E-E

Damage assessment drawings: These drawings aim to identify the places of damage in the school, by means of colors, hatches and writings.

For example, in the following figure, we find a section showing the damaged on the school.

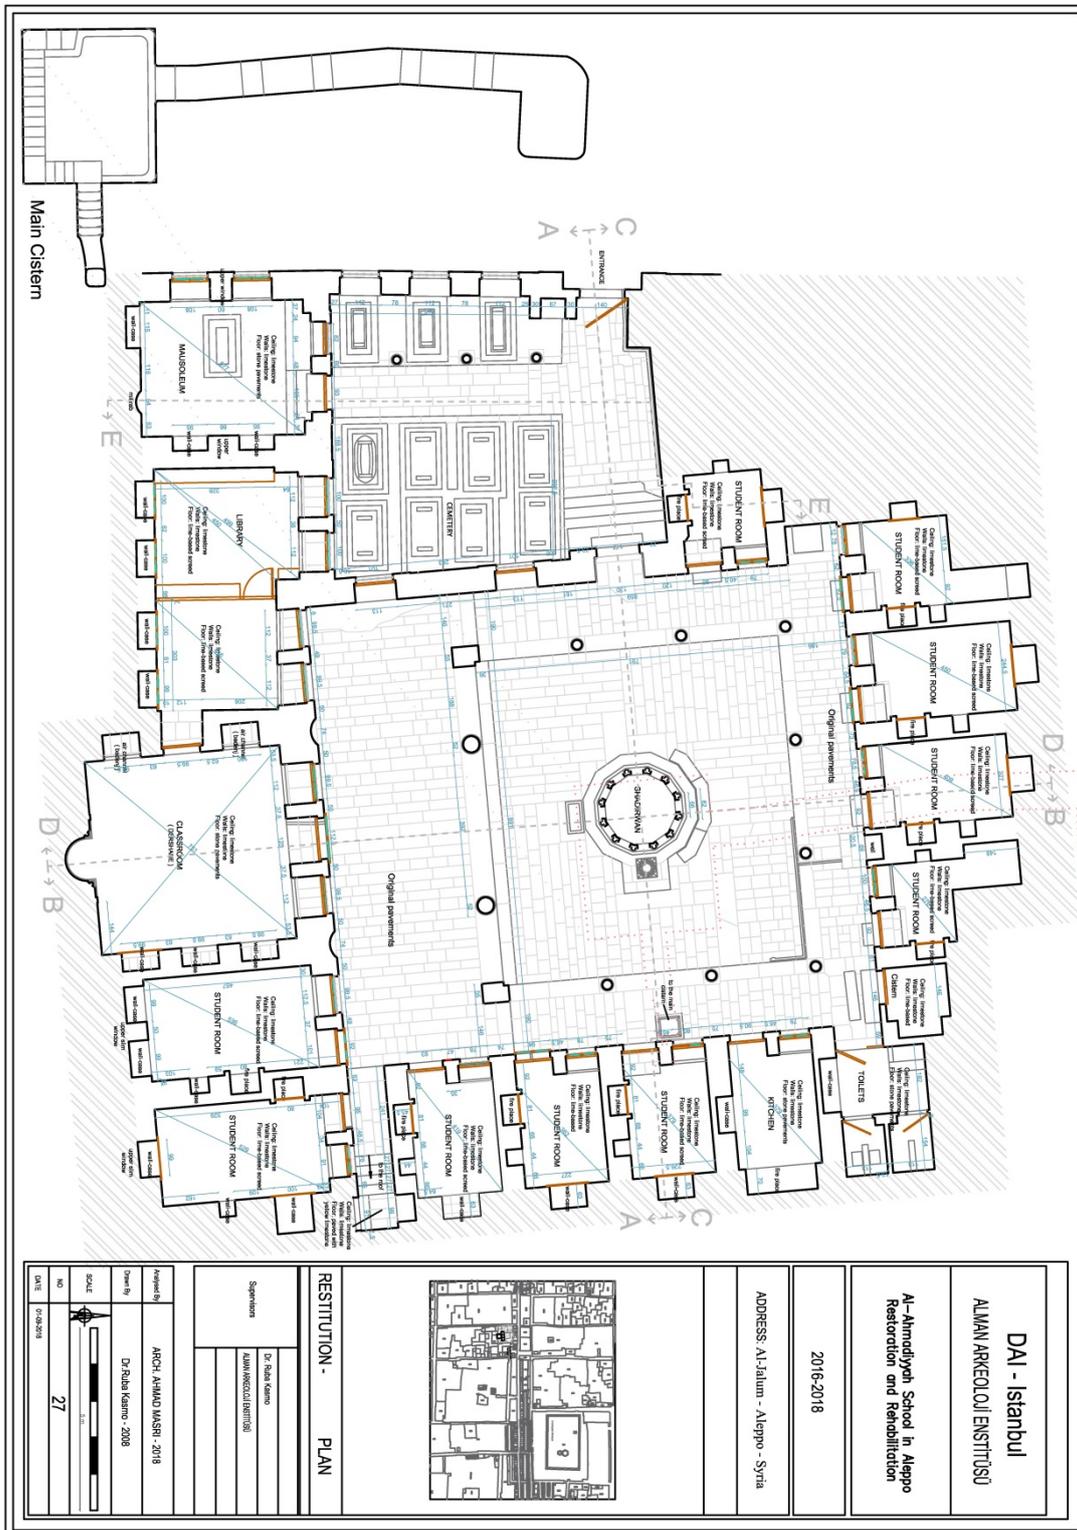
Restitution / The plan of the school

Restitution drawings: These drawings illustrates the original design of the school, the drawings were done by using old photos and available information about the school.

For example, in the following figure, we find an original plan of the school with writing illustrate the use of every space in the school and the used materials.

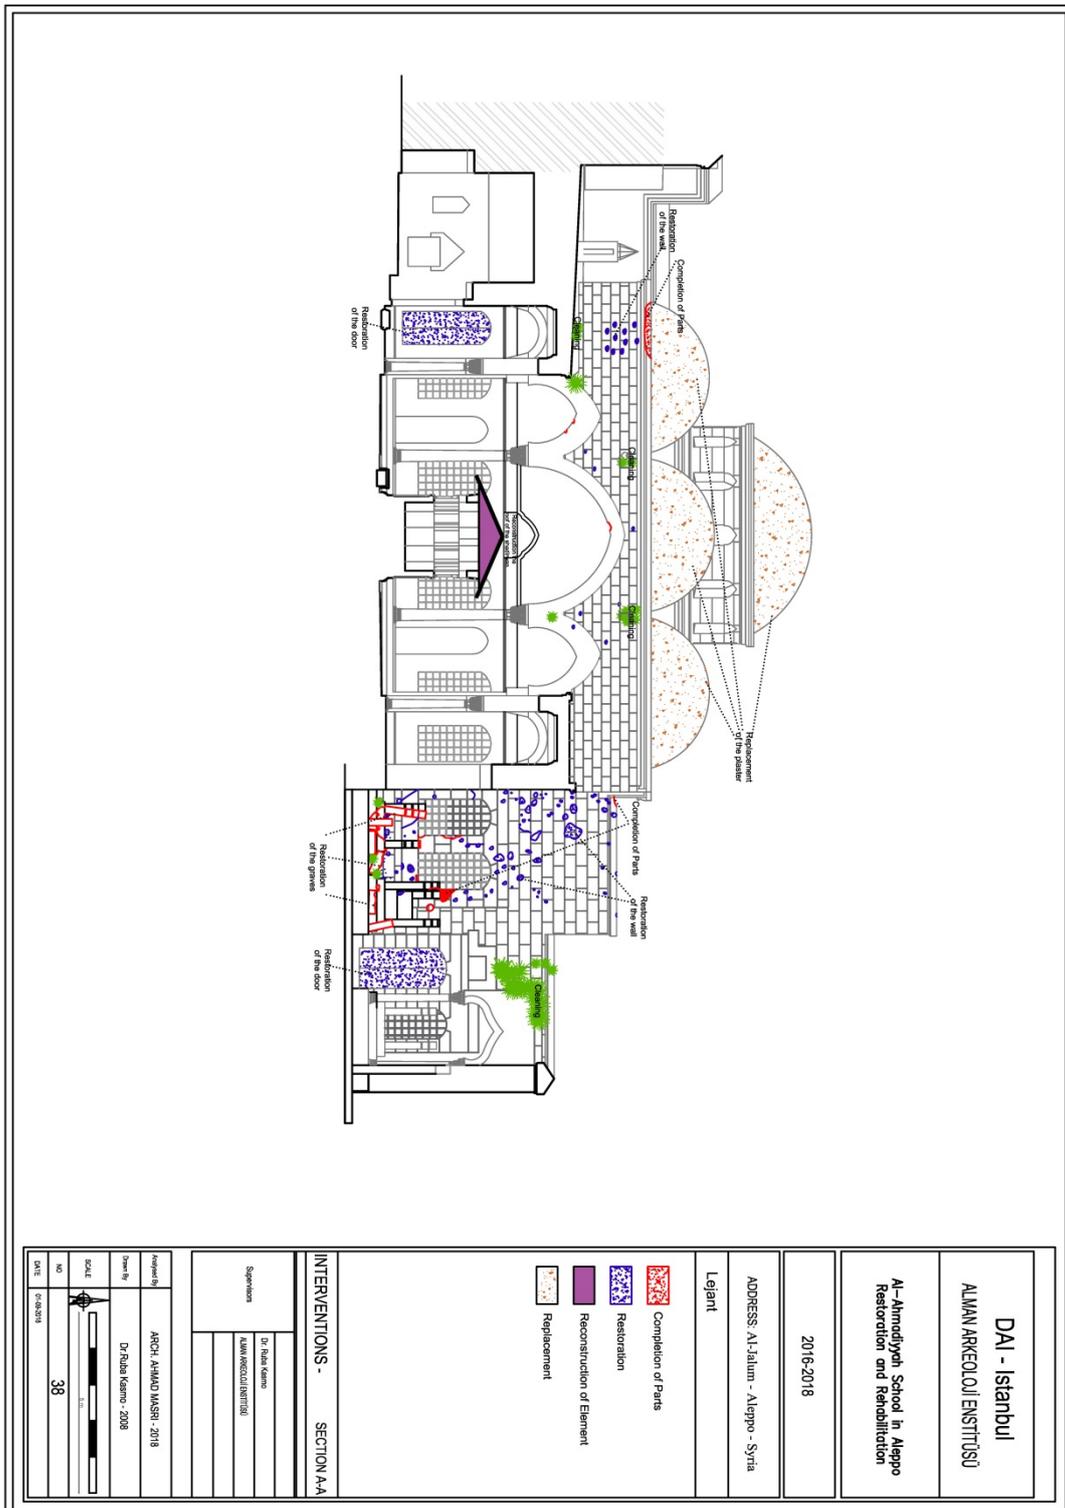
Interventions / Section A-A

For example, in the following figure, we can see some of the interventions suggested. These interventions were explained in the drawings by colors, hatching and writing.

Interventions drawings: These drawings aim to clarify the necessary interventions that will be implemented in the school, which are mentioned in detail in the restoration study.

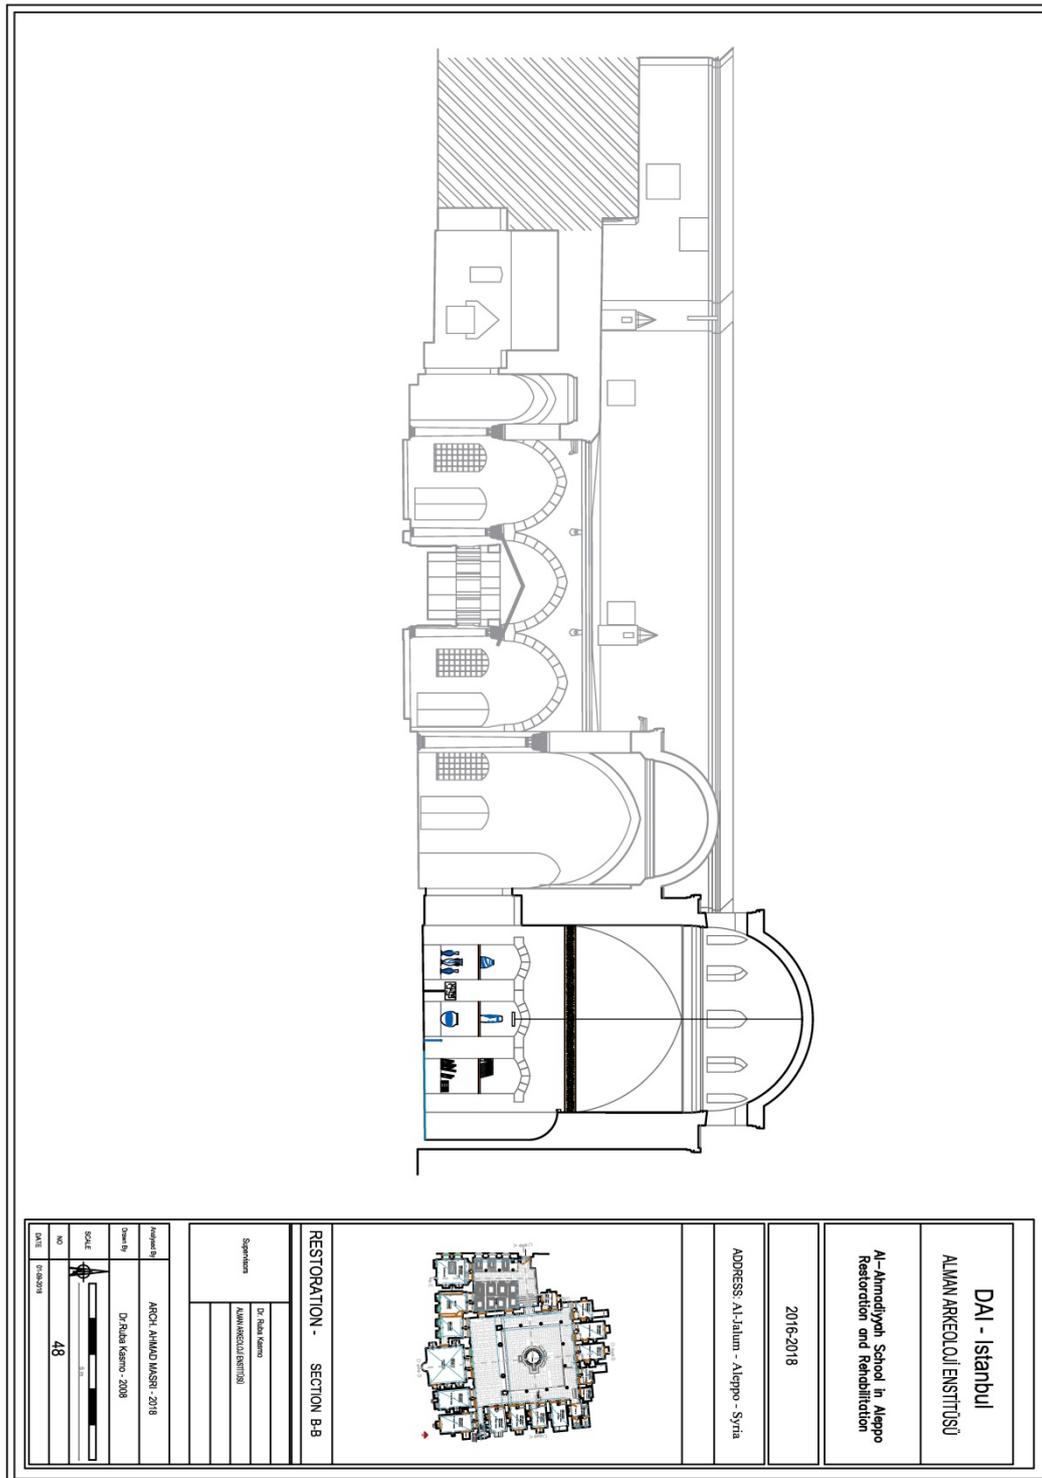
Restoration / Section B-B

Restoration drawings: These drawings illustrate the design of the school after implementing the necessary interventions; they also illustrate the design that demonstrates the function of the building. This too was mentioned in the study.

For example, in the following figure, we can find a section showing how the school will be with some furniture in it.

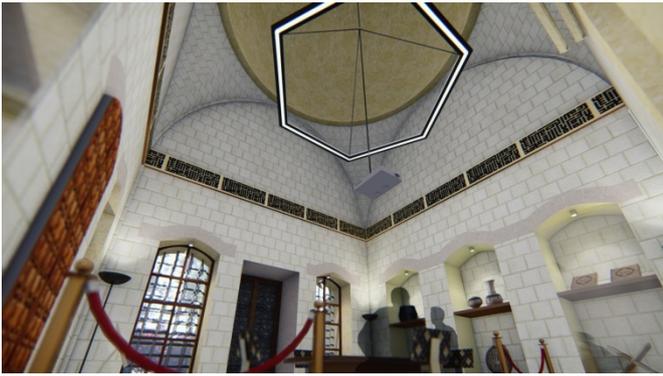
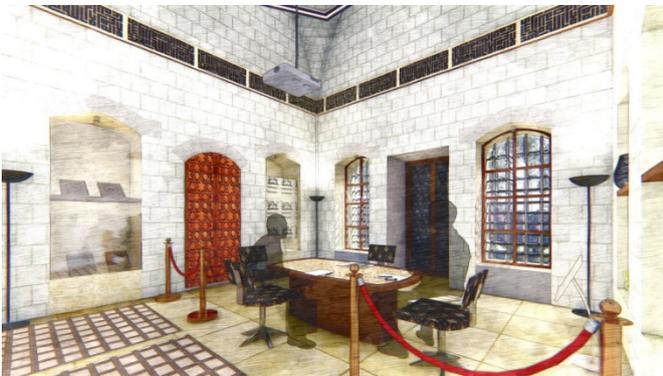
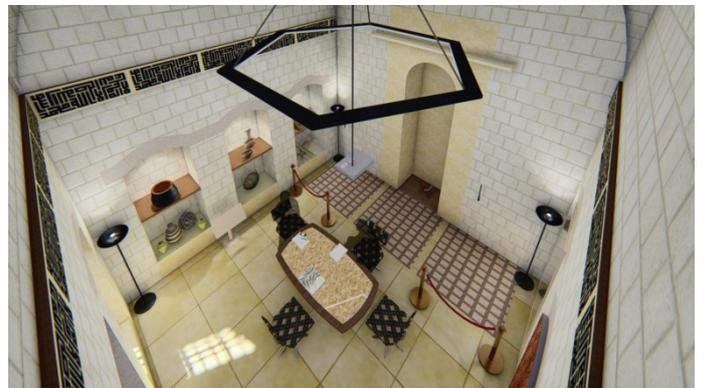
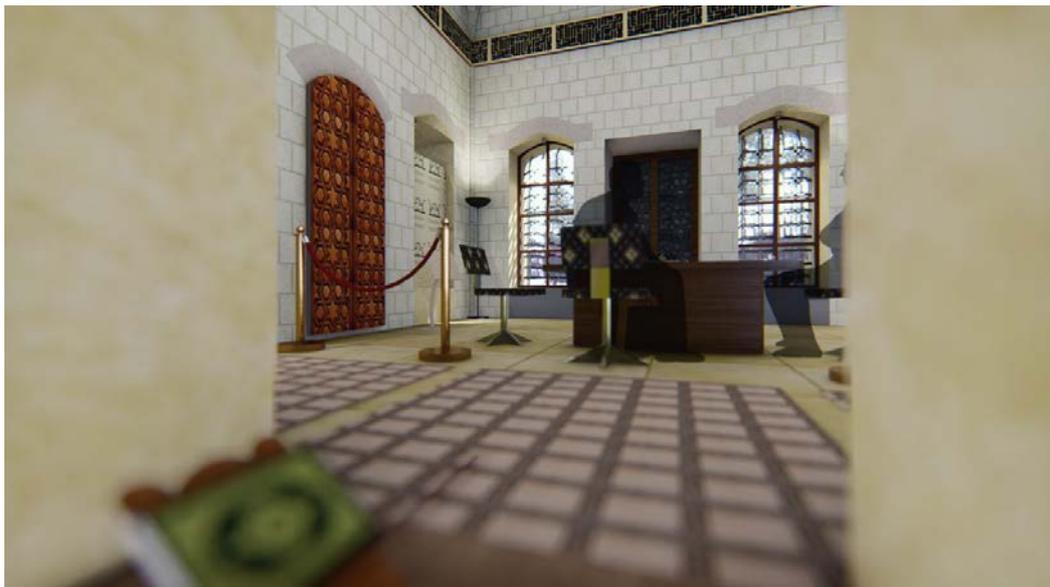
The Meeting Room

- Place of prayer: given the previous function of this room, we found that placing a small prayer place next to the mihrab might be appropriate to preserve the historic spirit of the building.
- Movable meeting table.
- 2 cupboards for antique Qurans.
- Historical objects.
- Posters for famous scientists and persons (on stands).
- Poster about ventilation system (In the West cupboard)
- On the upper cornice: paintings with Ottoman calligraphy on the perimeter of the hall.

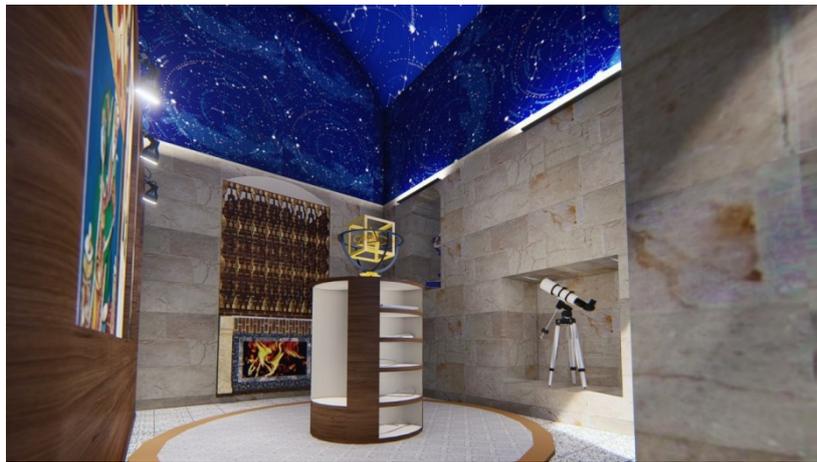
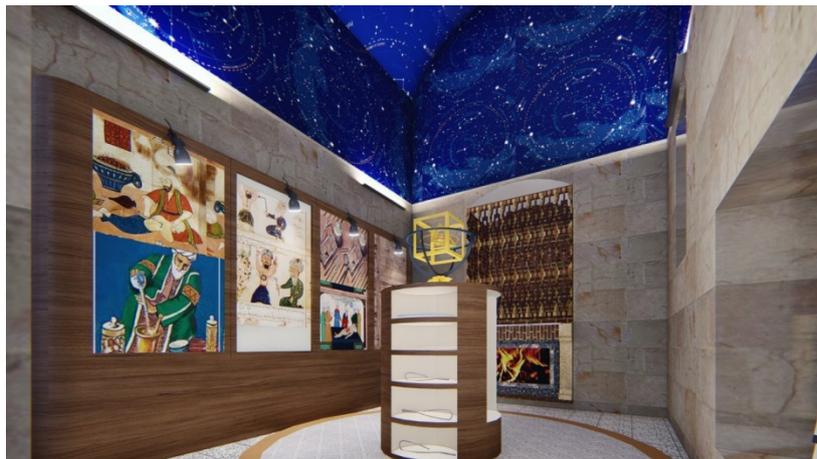
Another example, Medicine and Astronomy Showroom (R8), it will contain the following items:

- Two Display Cabinets contain Astrological and medical instruments.
- Poster about Medicine.
- Poster about Astronomy.
- Ceiling poster for Astronomy with variable lighting.
- Fireplace.
